# CITY OF WEST UNIVERSITY PLACE FACILITIES CONDITION ASSESSMENT + RECOMMENDATIONS REPORT

MAY 2021

PGAL

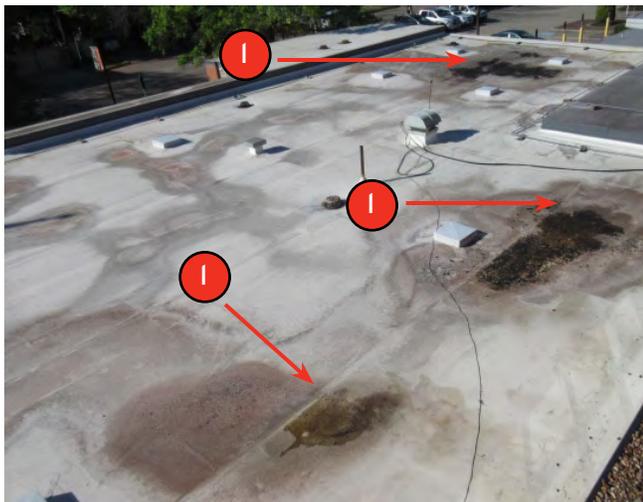
The exterior of the building is in good condition except for the Fire Bay roof and the Thermoplastic Polyolefin (TPO) roofing over the Administration/HR and Council chamber portions. A feasibility study to modify the Fire Bay was done in 2019 where various options were presented. It is recommended that the bay be replaced or at a minimum the roof be replaced in the near future, utilizing one of the options presented in the 2019 assessment. The TPO roof over the Admin/HR/Council chamber area is showing signs of ponding and will need to be repaired soon.

- 1 Roof Ponding
- 2 Fire Bays Roof

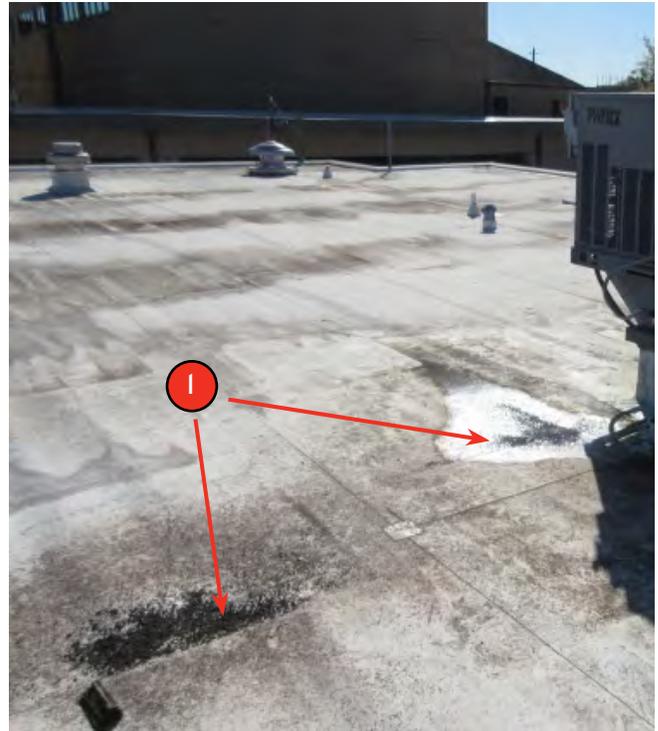
At the Operations Building the exterior of the building is in good condition although the TPO roof is showing signs of ponding and will need to be repaired soon. The interior walls are showing a bit of wear and are in need of repainting. The woman's locker room will need the sink replaced and grab-bars added to the water closet to ensure that the restroom is ADA compliant.

- 1 Roof Ponding
- 2 Scuffs on Walls
- 3 Woman's Sink is not ADA Accessible

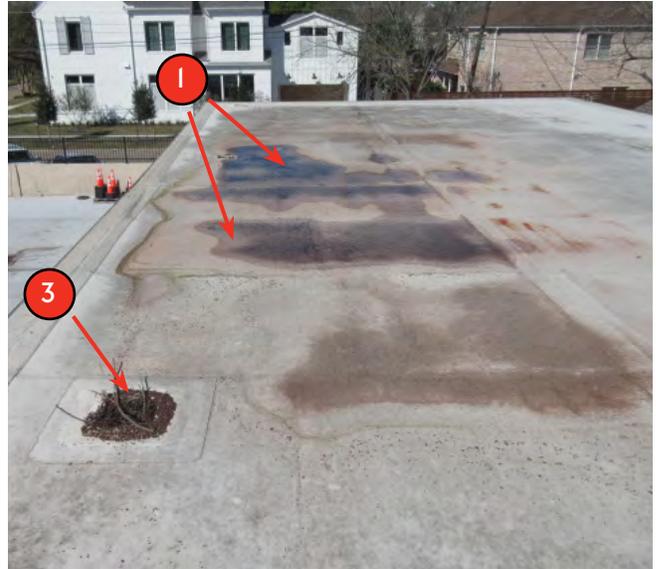
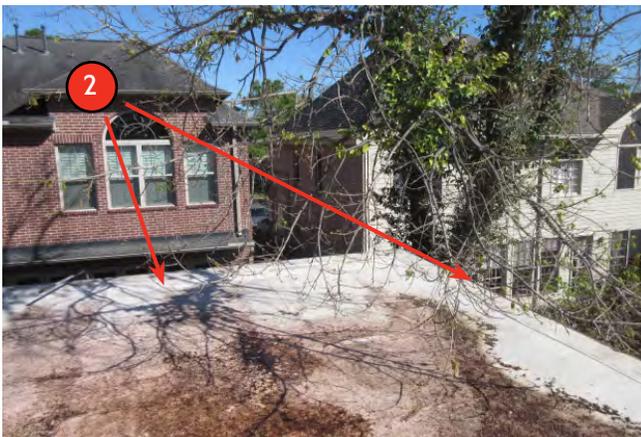
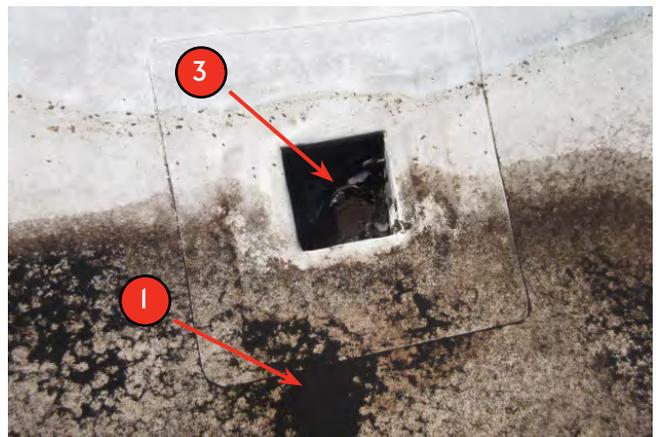
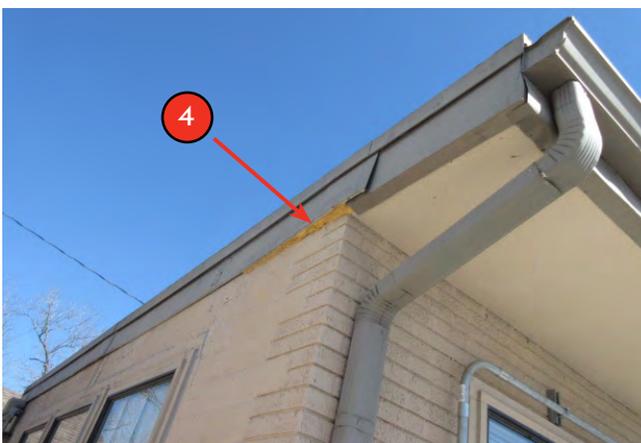
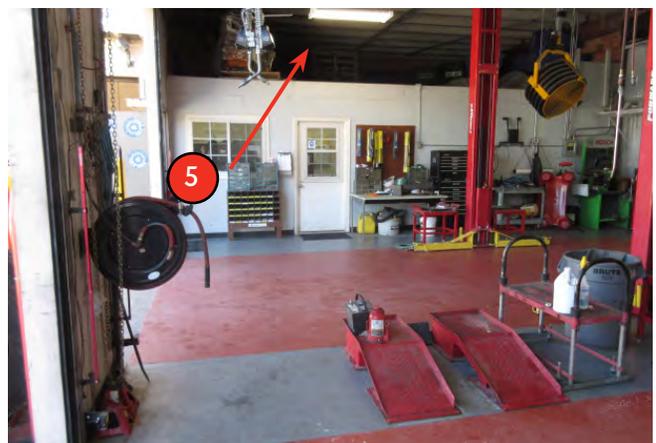
The exterior is in fair condition with the exception of the roofing, which is showing signs of ponding, a drain needing a new screen to keep debris out of the drain system, and the fascia needing repairs. The interior spaces are in good condition. Additional access to storage above the Fleet Maintenance offices can be achieved by adding a door in the wall of the mezzanine (located at the corner of the L-shape).

- 1 Roof Ponding
- 2 Trim Tree Branches
- 3 Clean Drain Out + Add Screen Cap
- 4 Fascia
- 5 Storage Area Needs Access

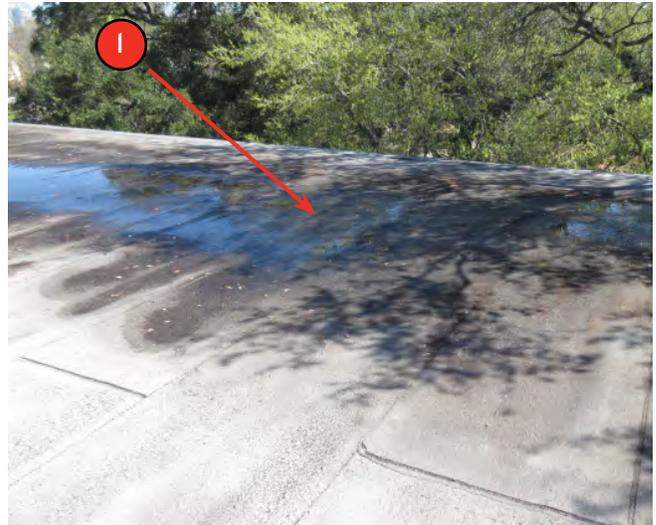
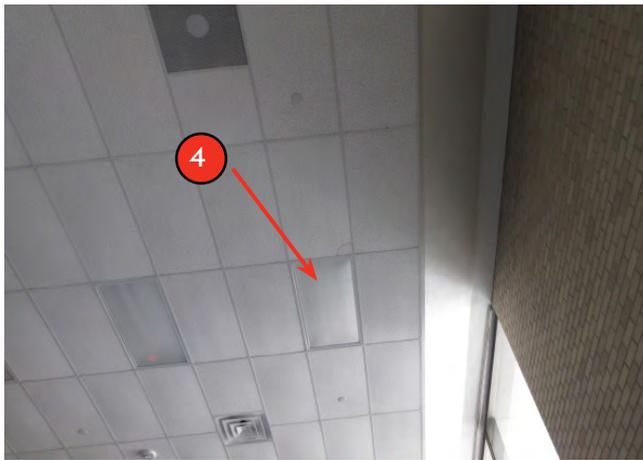
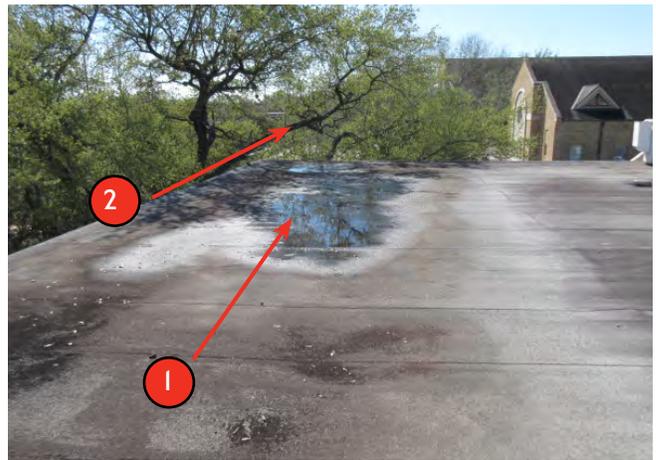
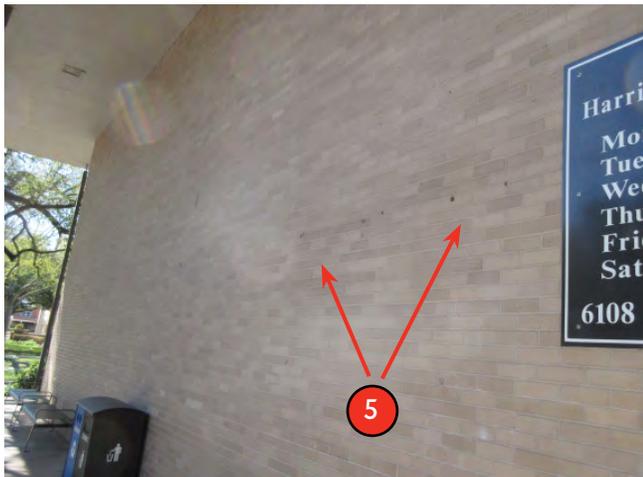
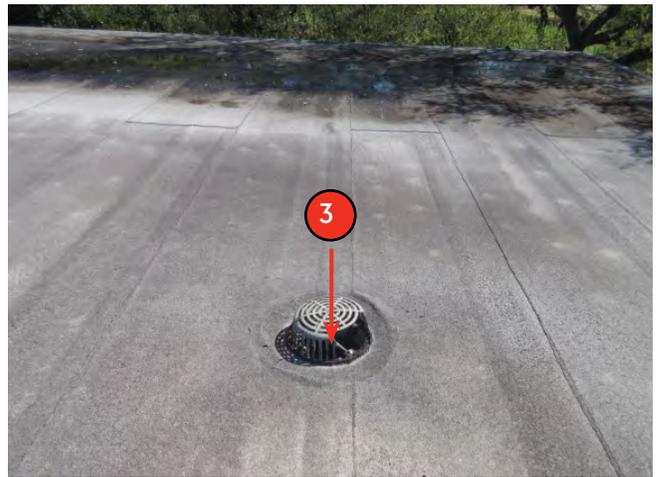
The exterior of the building is in good condition although the roof is showing signs of ponding that will need to be addressed, and there are minor repairs needed to patch a few holes in the brick.

- 1 Roof Ponding
- 2 Trim Tree Branches
- 3 Drain Cap Broken
- 4 Stained Ceiling Tile
- 5 Holes in Brick from Signage

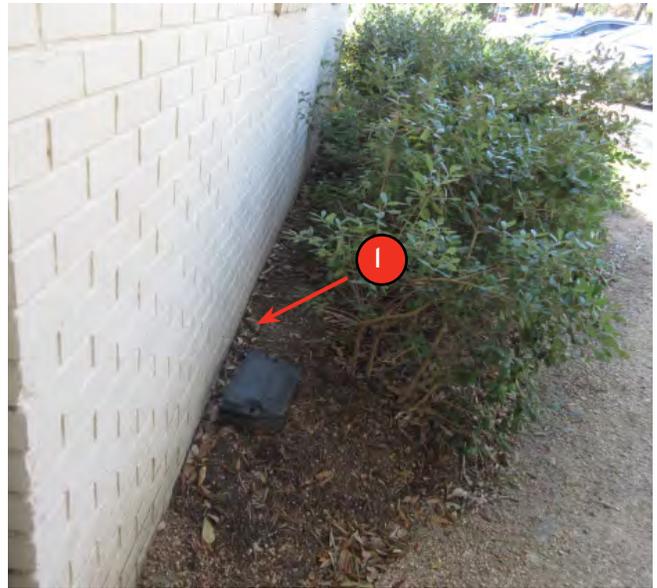
**Landscape Bed**

**I** Landscape Bed too High

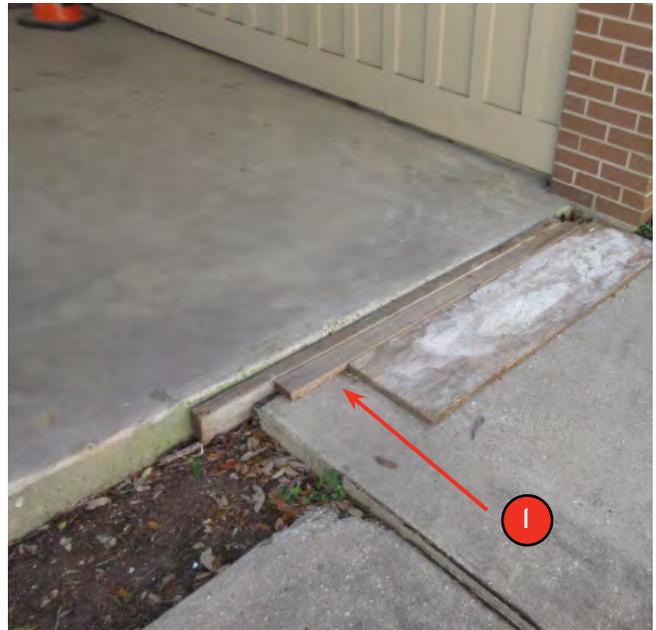
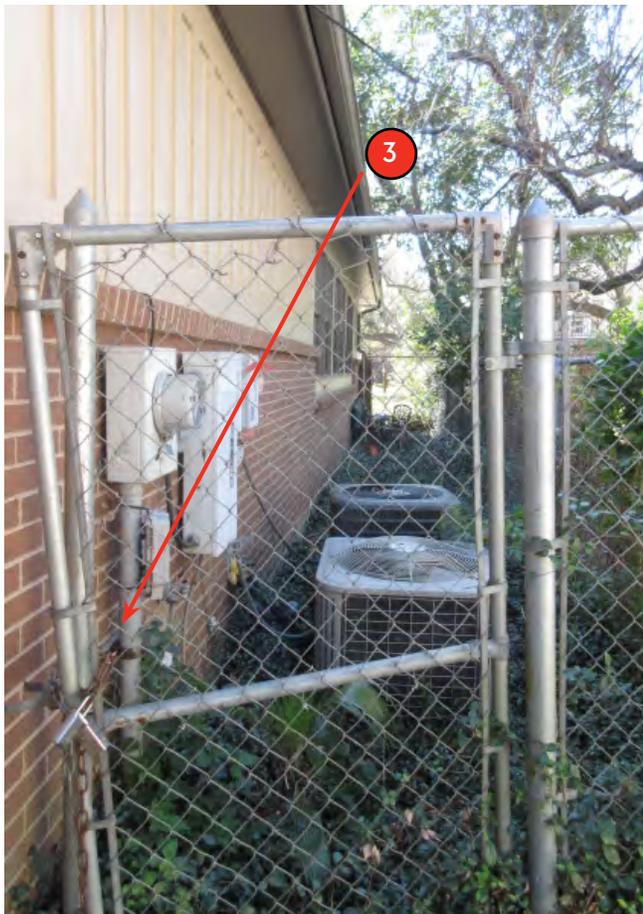
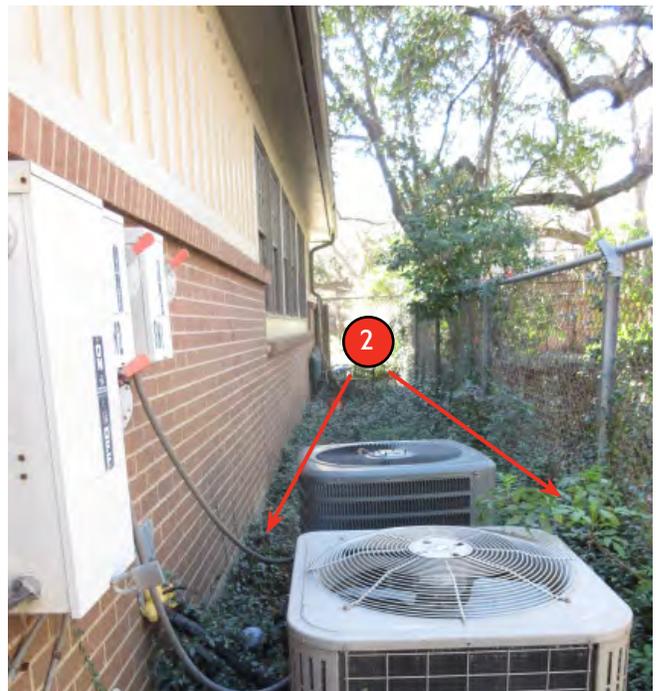
Outside, a chain link fence on the side of the building encloses the air conditioning units. The man gate to this area is skewed and will need correcting to keep the gate in proper working order. The sidewalk to the front porch has shifted and will need to be modified slightly to ensure ADA compliance.

- 1** Offset at Sidewalk
- 2** Remove Vegetation from Walls & Equipment
- 3** Man Gate is Skewed

| Projected Budget | Square Feet | Cost/SF | Subtotal | |
|--|---|---|--|---|
| Scout House, Man gate | 5 | \$ 400.00 | \$ 2,000.00 | repair or replace gate |

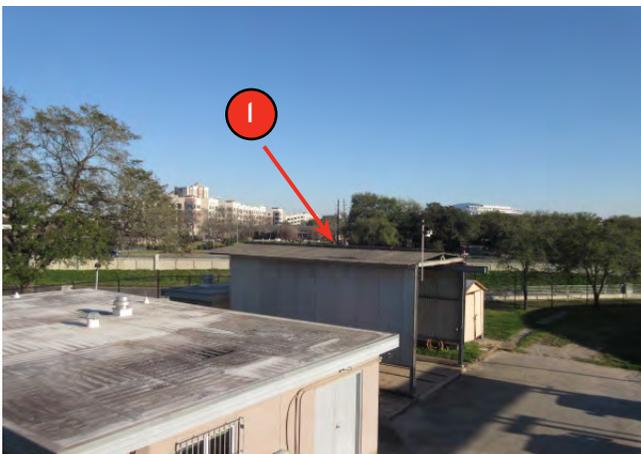
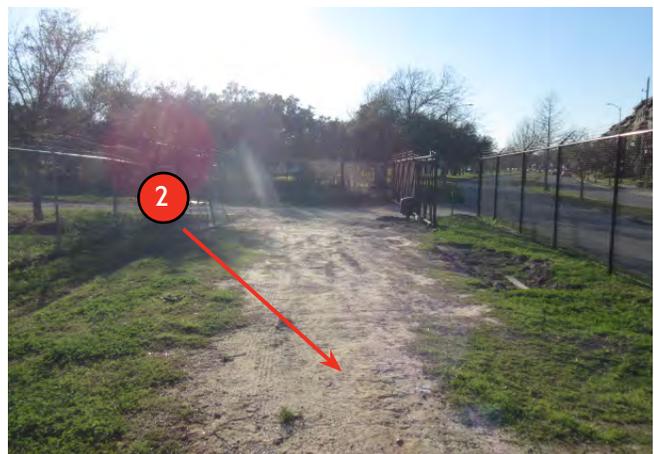
Adjacent to the plant is a separately fenced storage lot and the Animal Kennel. The 492 square foot, 6 kennel, Animal Kennel was built in 1985, renovated in 2018, and is currently in good condition. The surfacing to access the Kennel could use new gravel or new hard surfacing.

- 1 Chlorine Storage
- 2 Animal Kennel Site Surfacing
