Pavement Management Report

City of West University Place, Texas

March 25, 2022

Terracon Project No. 92215152

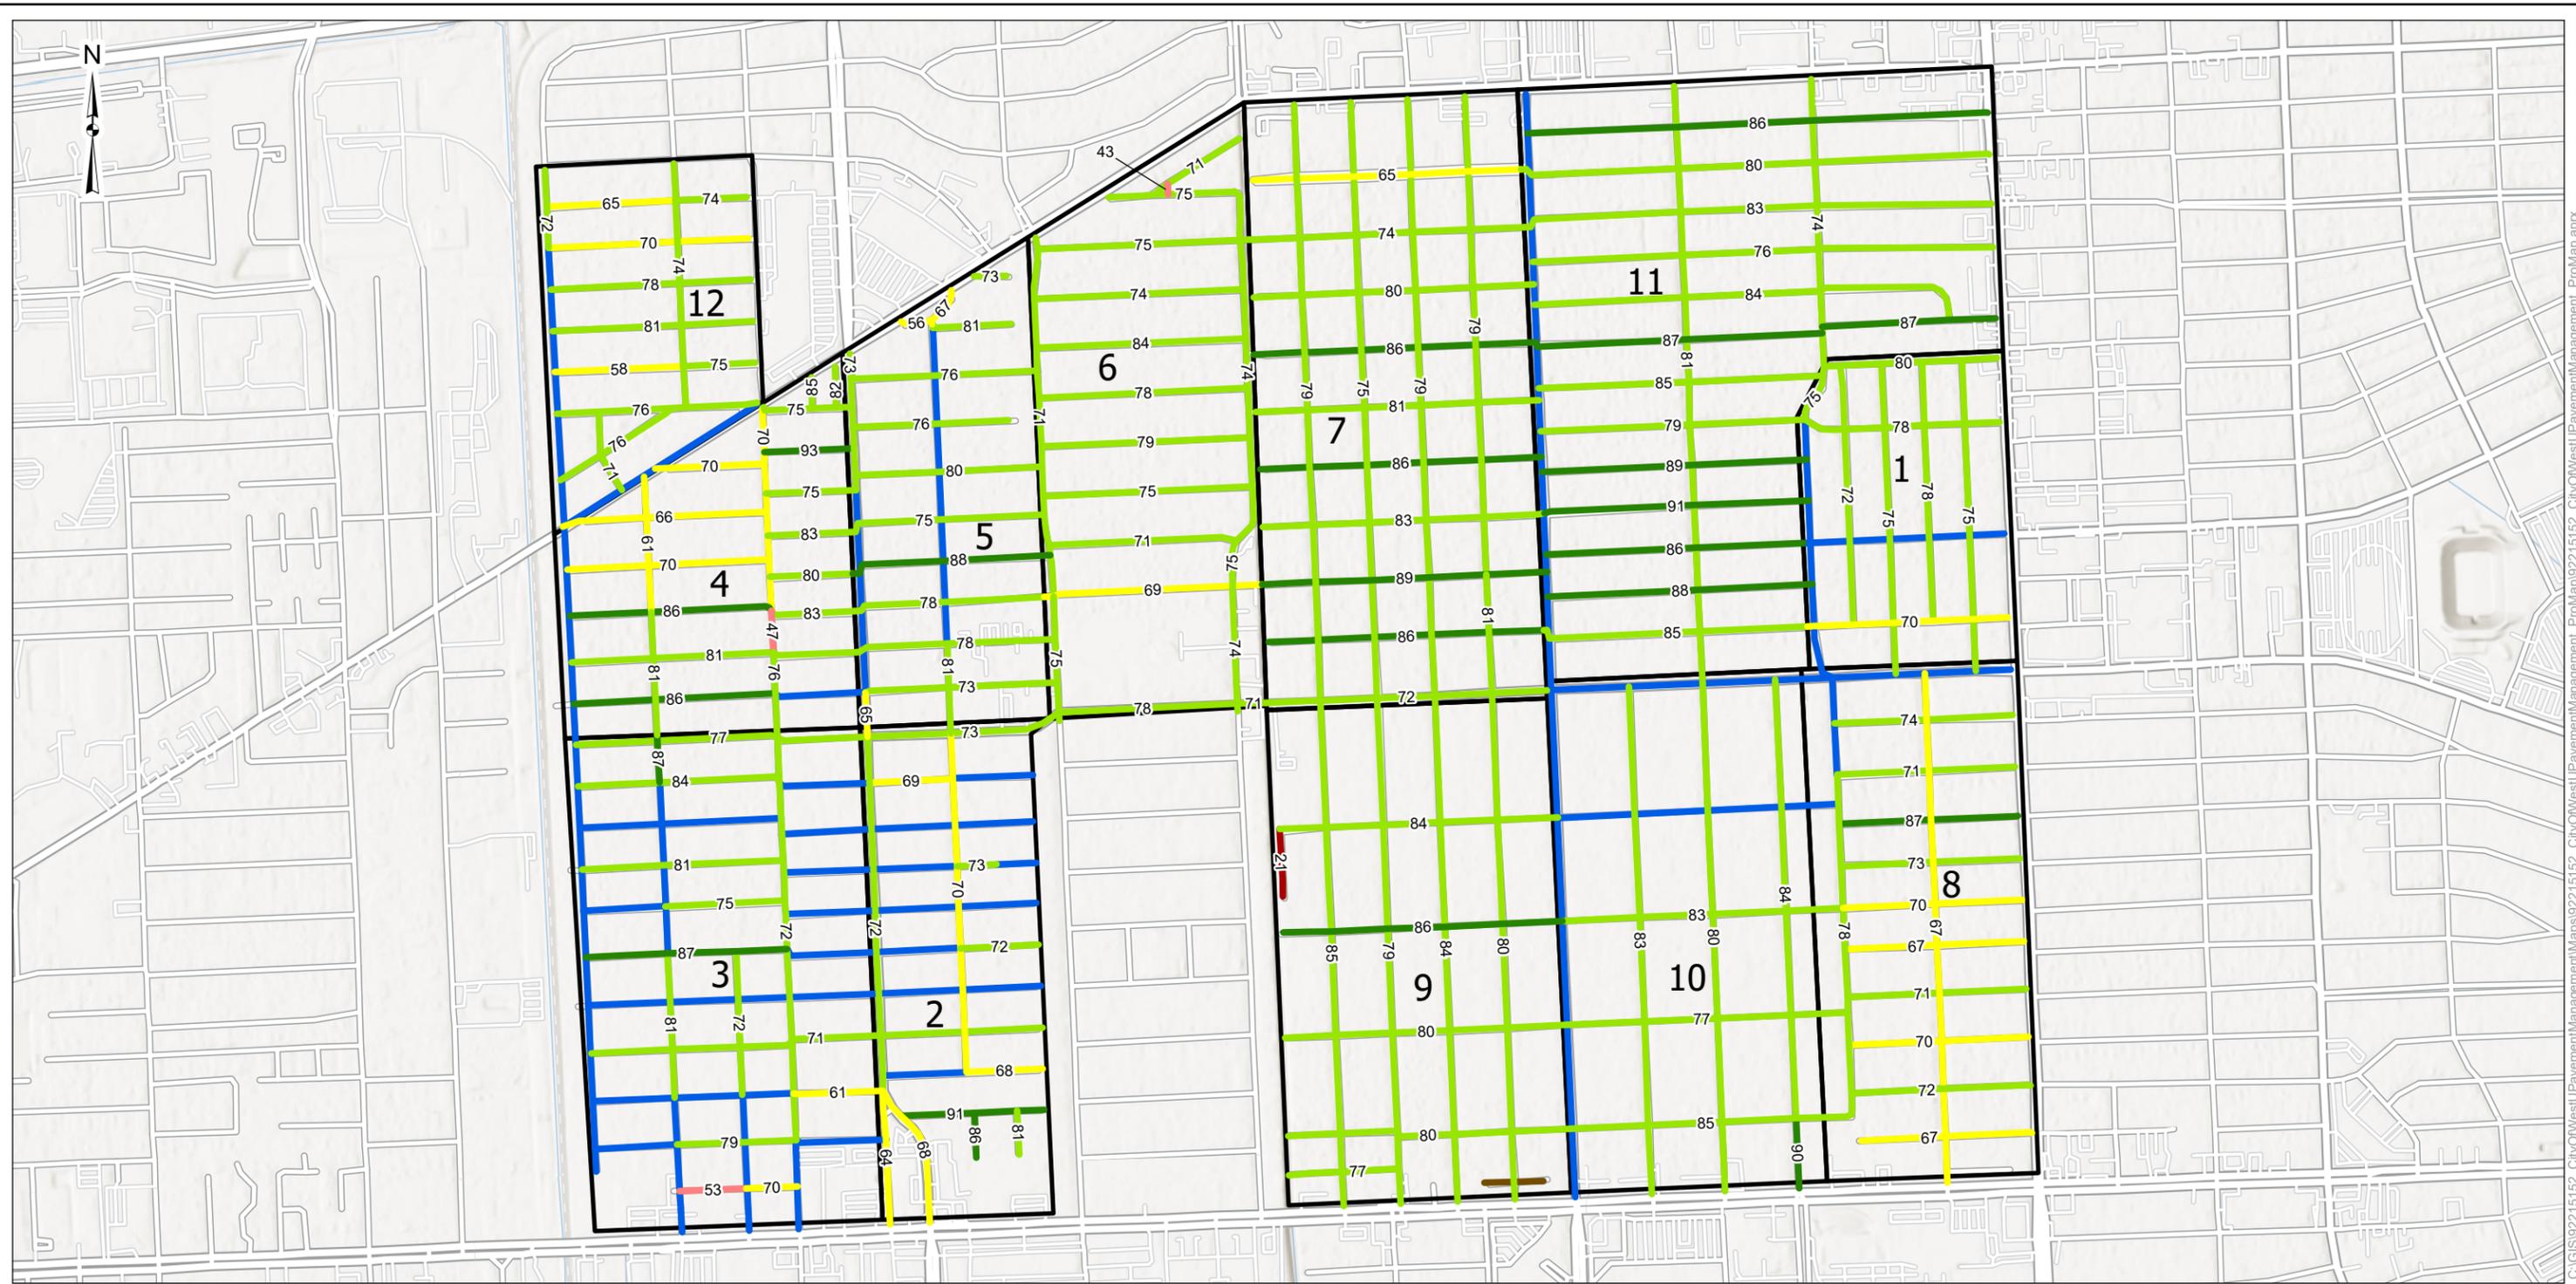
Exhibit A-3 shows a map of the Pavement Condition rating of each street based on the 2021 pavement condition inspections. The weighted average PCI of the streets, in terms of length, is 78. The majority of the streets at the time of inspection are in considered to be in a Satisfactory condition. **Table 2** below provides an overall summary of the 2021 PCI of the entire pavement network within the City.

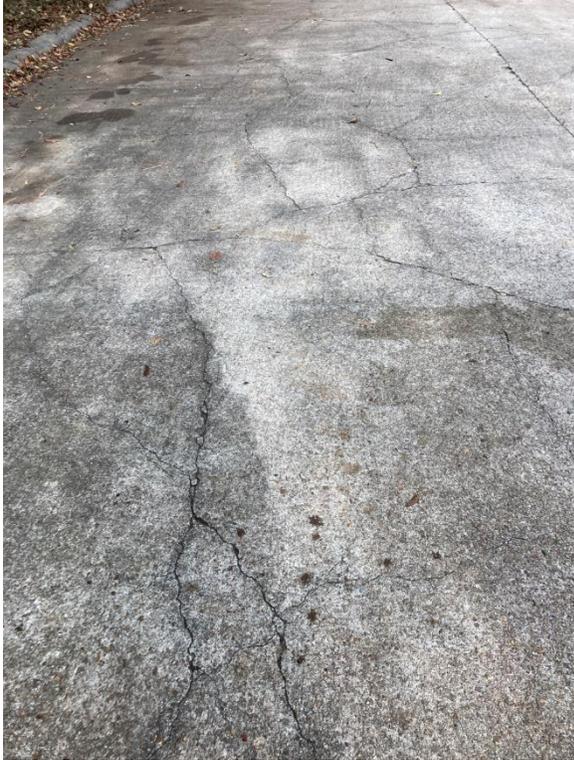
- **Divided Slab:** This distress is characterized by a slab that is divided by cracks into four or more pieces. Divided slab is usually the result of overloading and/or inadequate support.

Photo #1 Divided slab observed on Virginia Court (Section ID: 69).

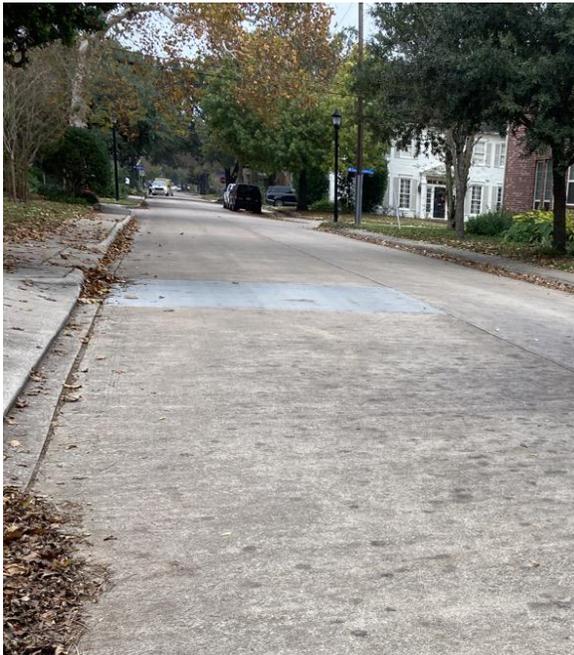
2. Pumping or eroding of material from under the slab.
 3. Curling of the slab edges due to temperature and moisture changes.
- **Patching, Large, and Utility Cuts:** A patch is an area where the original pavement has been removed and replaced by filler material. A utility cut is a patch that has replaced the original pavement to allow the installation or maintenance of underground utilities.

Photo #2 Patching observed on West Point Street (Section ID: 168).

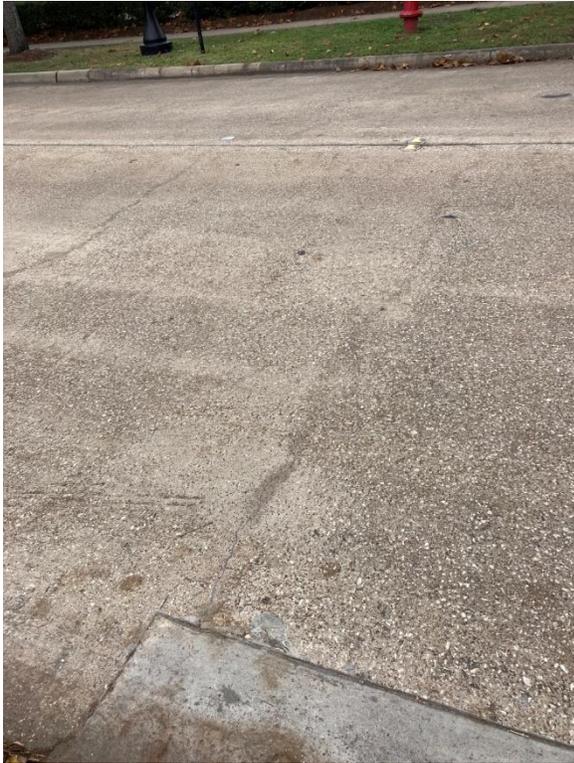
- **Patching, Small and Utility Cuts:** A patch is an area where the original pavement has been removed and replaced by filler material.
- **Polished Aggregate:** This distress is caused by repeated traffic applications. Polished aggregate is present when close examination of a pavement reveals that the portion of aggregate extending above the pavement is either very small, or there are no rough or angular aggregate particles to provide good skid resistance.

Photo #3 Polished aggregate observed on University Boulevard (Section ID: 109).

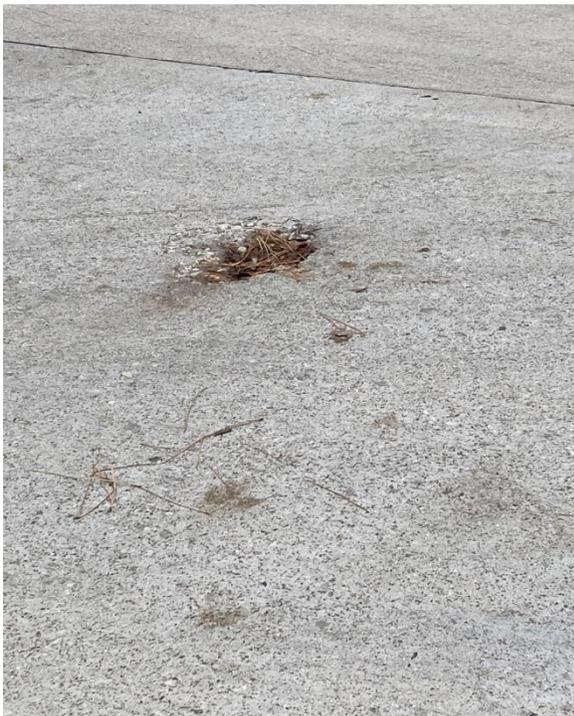
- **Popouts:** A popout is a small piece of pavement that breaks loose from the surface due to freeze-thaw action, combined with expansive aggregates. Popouts usually range in diameter from approximately 1 to 4 in. and in depth from 1/2 to 2 in.

Photo #4 Popouts observed on College Street (Section ID: 123).

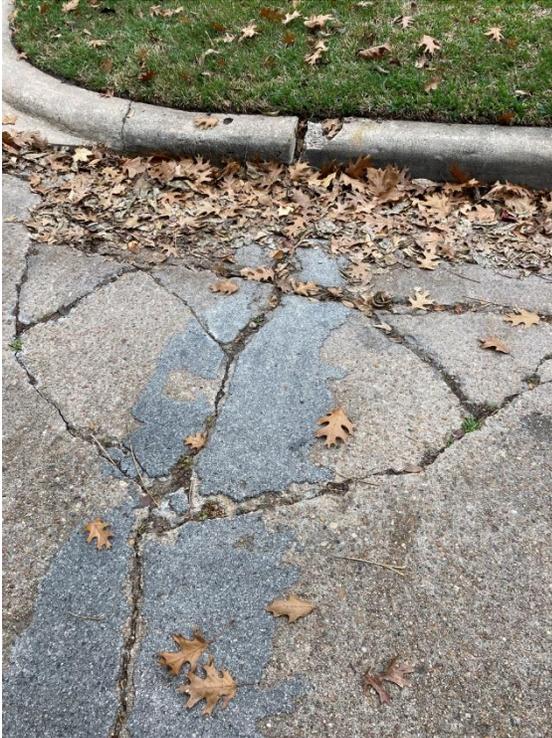
- **Punchout:** This distress is a localized area of the slab that is broken into pieces. The punchout can take many different shapes and forms, but it is usually defined by a crack and a joint. This distress is caused by heavy repeated loads, inadequate slab thickness, loss of foundation support, and/or a localized concrete construction deficiency (e.g. honeycombing).

Photo #5 Punchout observed on Riley Street (Section ID: 121).

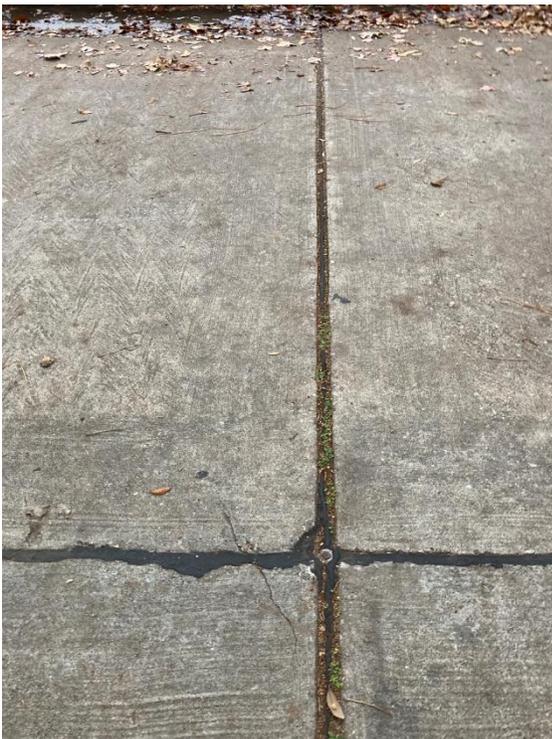
- **Joint Seal Damage:** Joint seal damage is any condition that enables soil or rocks to accumulate in the joints or allows significant water infiltration. Accumulation of incompressible materials prevents the slab from expanding and may result in buckling, shattering, or spalling. Typical types of joint seal damage are:
 1. Stripping of joint sealant.
 2. Extrusion of joint sealant.
 3. Weed growth.
 4. Hardening of the filler (oxidation).
 5. Loss of bond to the slab edges.
 6. Lack or absence of sealant in the joint.

Photo #6 Joint seal damage observed on Oberlin Street (Section ID: 117).

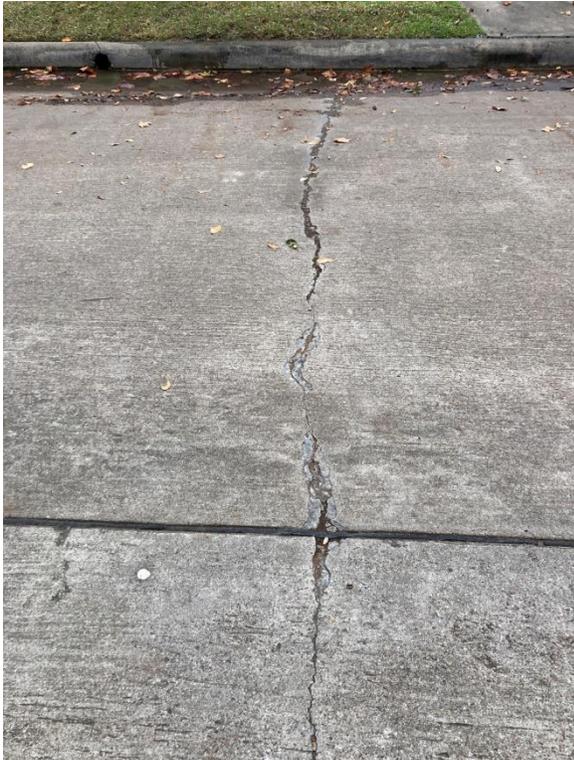
- **Linear Cracking (Longitudinal, Transverse, and Diagonal Cracks):** These cracks divide the slab into two or three pieces and are usually caused by a combination of repeated traffic loading, thermal gradient curling, and repeated moisture loading.

Photo #7 Linear cracking observed on Southwestern Street (Section ID; 120).

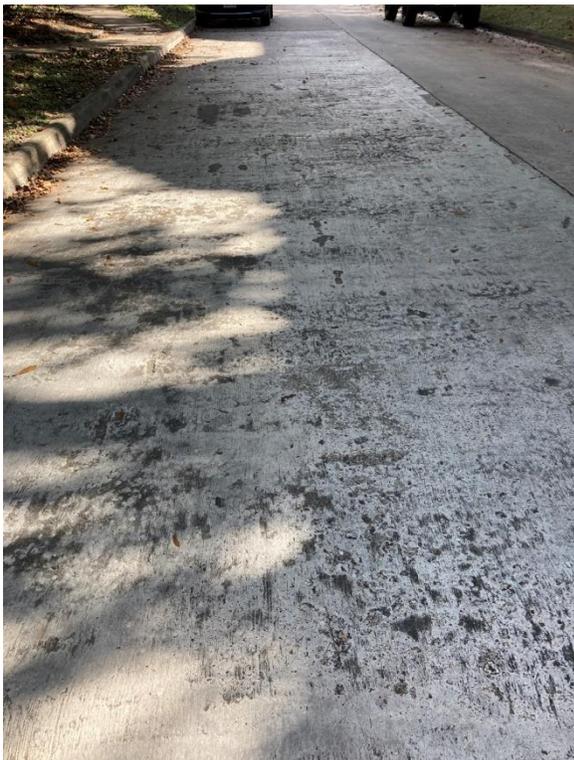
- **Scaling, Map Cracking, and Cracking:** Map cracking or crazing refers to a network of shallow, fine, or hairline cracks that extend only through the upper surface of the concrete. The cracks tend to intersect at angles of 120 degrees. Map cracking or crazing is usually caused by concrete over-finishing, and may lead to surface scaling, which is the breakdown of the slab surface to a depth of approximately 1/4 to 1/2 in. Scaling may also be caused by deicing salts, improper construction, freeze-thaw cycles, and poor aggregate.

Photo #8 Scaling and map cracking crazing observed on Carnegie Street (Section ID: 133).

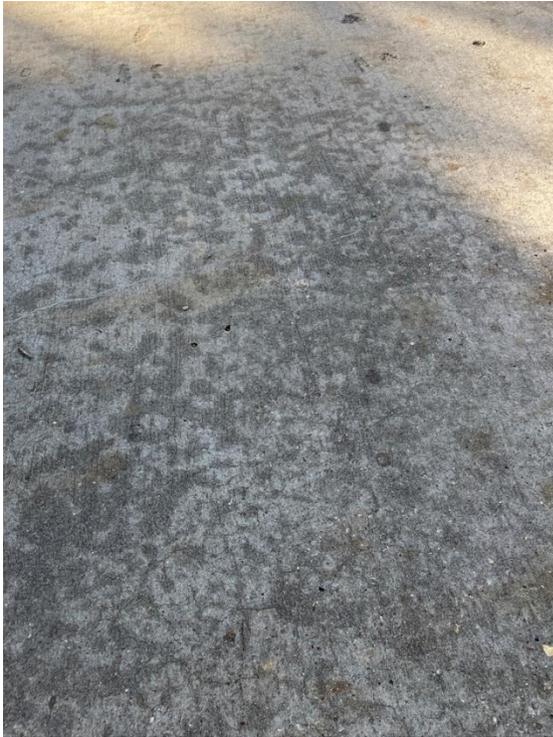
- **Shrinkage Cracks:** Shrinkage cracks are hairline cracks that are usually less than 6.6 ft long and do not extend across the entire slab. They are formed during the setting and curing of the concrete and usually do not extend through the depth of the slab.

Photo #9 Shrinkage cracks observed on Albans Street (Section ID: 85).

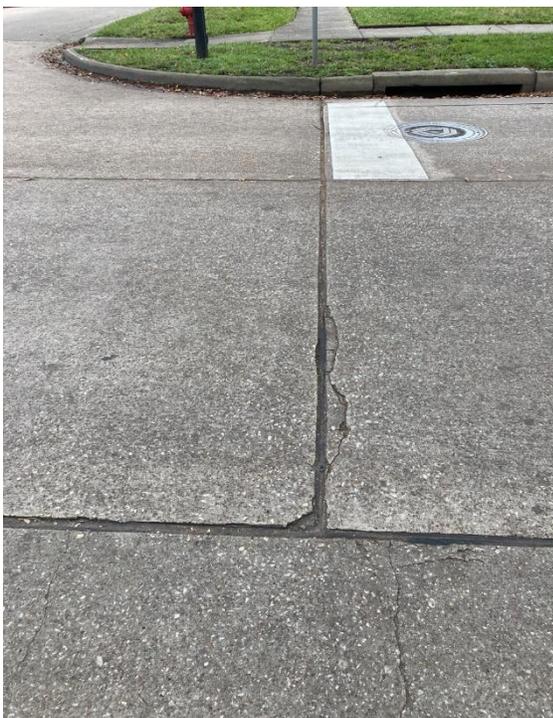
- **Spalling, Joint:** Joint spalling is the breakdown of the slab edges within 1-1/2 ft of the joint. A joint spall usually does not extend vertically through the slab, but intersects the joint at an angle. Spalling results from:
 1. Excessive stresses at the joint caused by traffic loading or by infiltration of incompressible materials.

2. Weak concrete at the joint caused by overworking.
3. Water accumulation in the joint and freeze-thaw action.

Photo #10 Joint spalling observed on Auden Street (Section ID: 7).
