# CITY OF WEST UNIVERSITY PLACE FACILITIES CONDITION ASSESSMENT + RECOMMENDATIONS REPORT

MAY 2021

PGAL

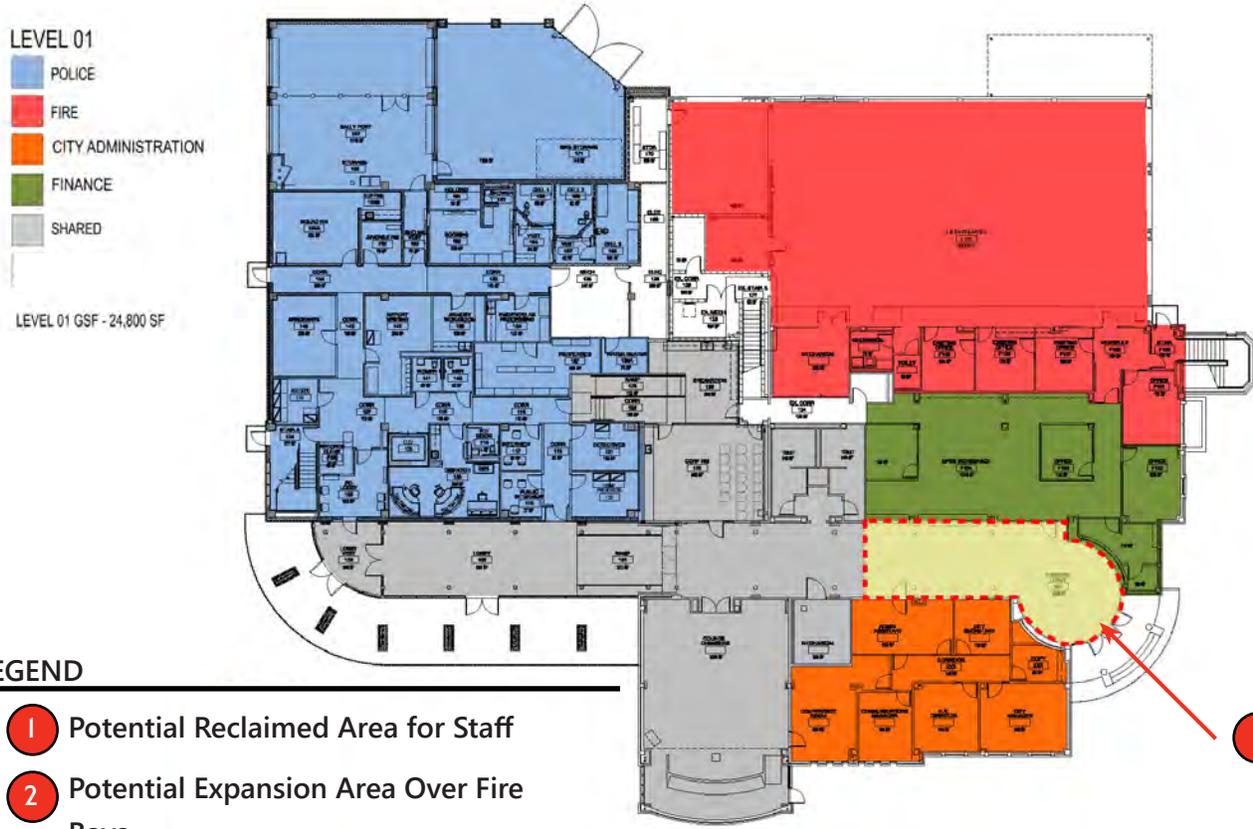
- 1 Potential Reclaimed Area for Staff
- 2 Potential Expansion Area Over Fire Bays

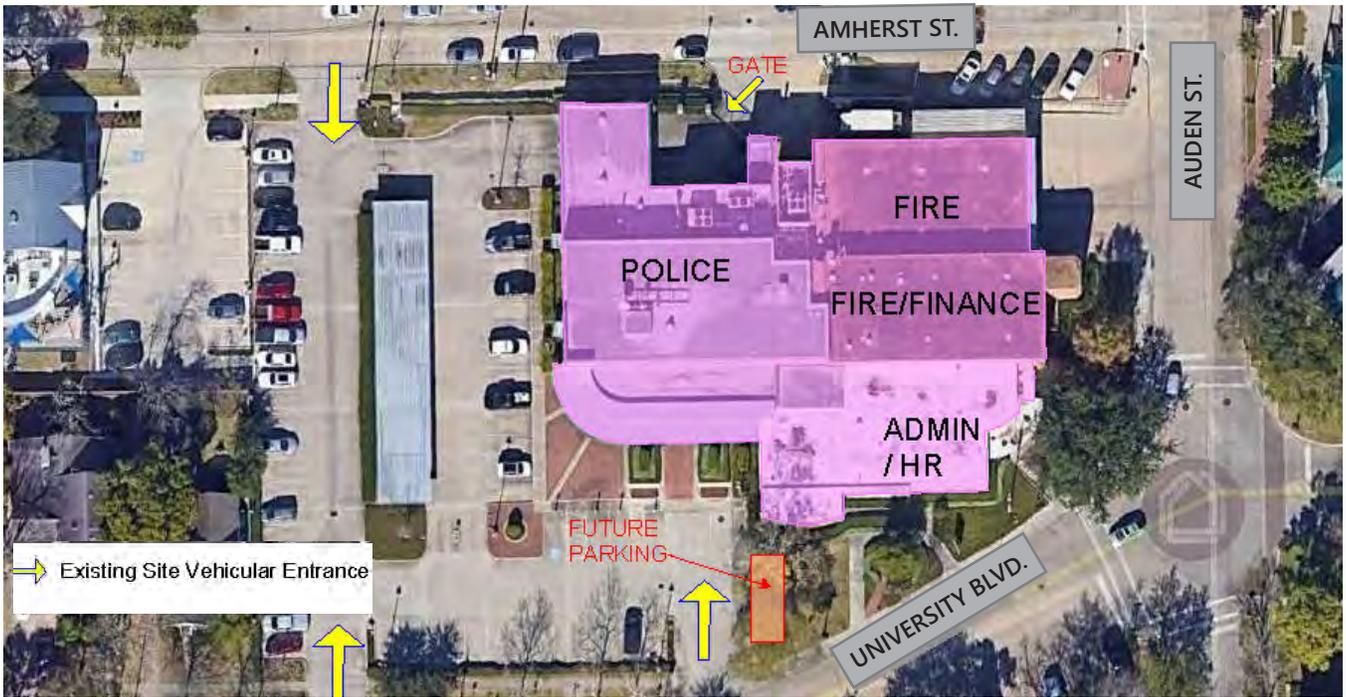
The exterior of the building is in good condition except for the Fire Bay roof and the Thermoplastic Polyolefin (TPO) roofing over the Administration/HR and Council chamber portions. A feasibility study to modify the Fire Bay was done in 2019 where various options were presented. It is recommended that the bay be replaced or at a minimum the roof be replaced in the near future, utilizing one of the options presented in the 2019 assessment. The TPO roof over the Admin/HR/Council chamber area is showing signs of ponding and will need to be repaired soon.

- 1 Roof Ponding
- 2 Fire Bays Roof

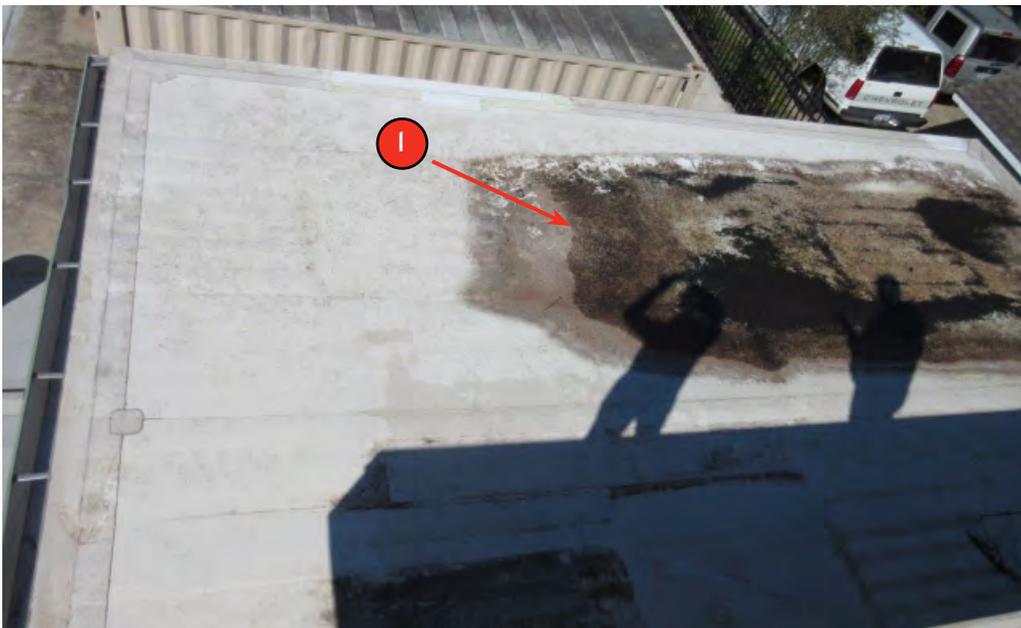
The exterior is in fair condition with the exception of the roofing, which is showing signs of ponding, a drain needing a new screen to keep debris out of the drain system, and the fascia needing repairs. The interior spaces are in good condition. Additional access to storage above the Fleet Maintenance offices can be achieved by adding a door in the wall of the mezzanine (located at the corner of the L-shape).

**Building Envelope:** This facility's exterior walls consist of a mix of painted CMU, brick, and stucco, that is currently in good condition. The building's foundations have no visible signs of foundation issues. The fascia at the west side of the building has been repaired with insulating foam that is currently exposed. This will need to be repaired properly with materials that match the exterior finishes. The roof is TPO and was replaced in 2011. It is in fair shape; however, the slope is not adequate for proper flow towards the drains as evidenced with standing/ponding water, two days after a rain event. It is recommended that the low areas be addressed to provide positive drainage. One of the roof drains does not have a debris screen and is currently clogged. The lower roof on the west side does not slope toward the gutter with evidence of standing water on the roof. Tree branches are overhanging the roof and will need to be trimmed on a regular basis, so they do not scratch or damage the roof membrane.

- 1 Roof Ponding
- 2 Trim Tree Branches
- 3 Clean Drain Out + Add Screen Cap
- 4 Fascia
- 5 Storage Area Needs Access

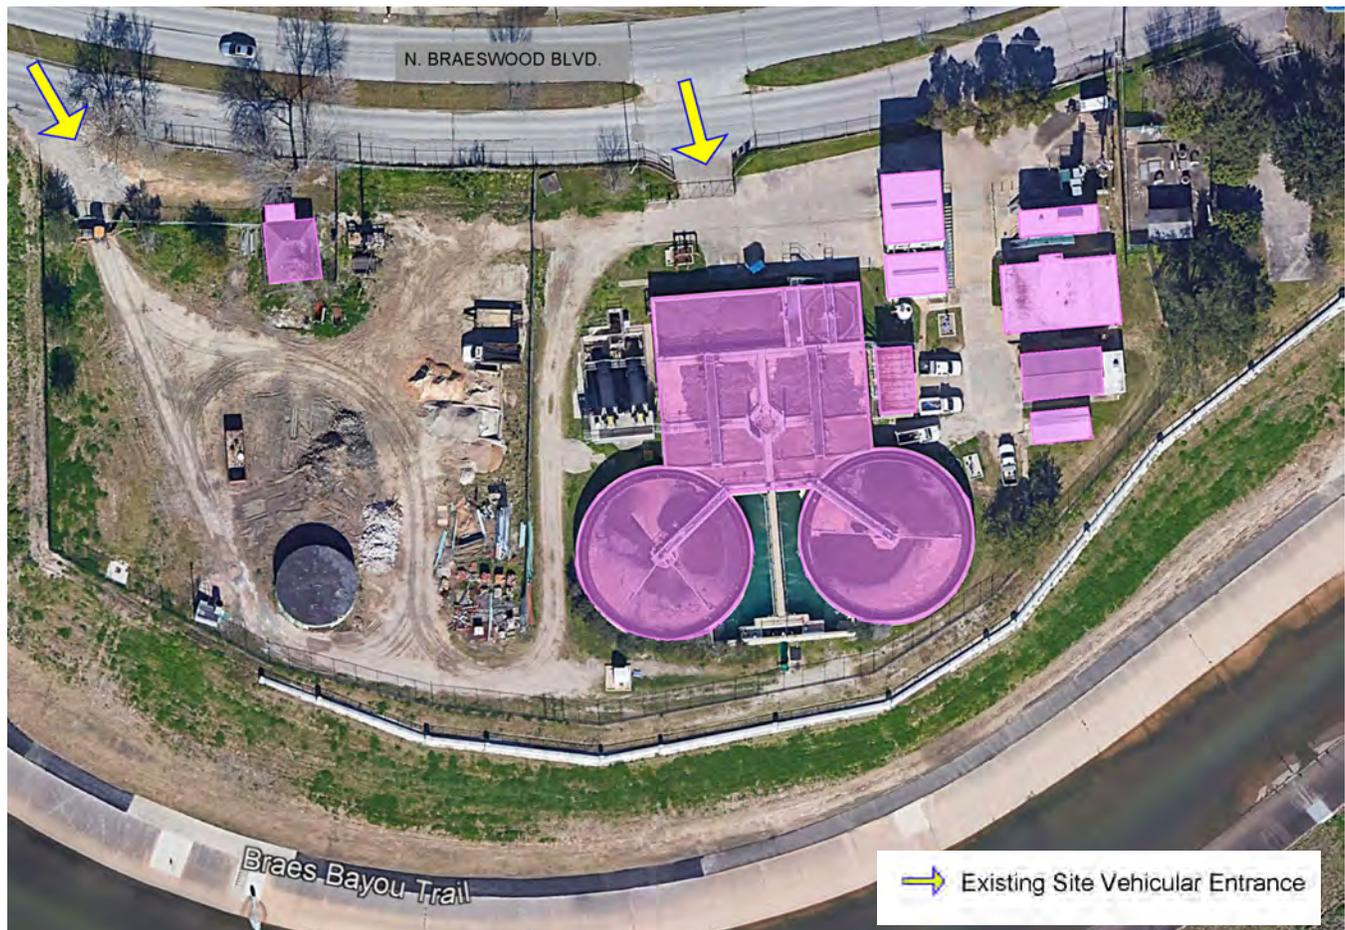
**Building Envelope:** The Wastewater Plant and Animal Kennel buildings' foundations have no visible signs of foundation issues. The Wastewater Plant has various buildings, the CMU walled building as well as the metal buildings and are in fair condition. The metal wash station is in fair to poor condition and shows signs of aging. The office building has a TPO roof that is in fair condition and was replaced in February of 2013. It is showing signs of ponding due to insufficient slope. The roofs on the metal buildings are in good condition

yet the wash station roof is not. It is in poor condition and will need to be rehabbed soon in order to prolong its life. Rusted or damaged areas in the metal siding and roof need to be treated and the whole building repainted. The Animal Kennel exterior walls are composed of painted wood panels and are in fair condition with no visible rot. The Animal Kennel was deemed insufficient to meet the City's needs and was in consideration for replacement. The location of the building within the Floodway made the replacement financially unfeasible and was delayed. The Animal Kennel was renovated instead.
